San Jacinto River Waste Pits Superfund Site Overview

September 22, 2011

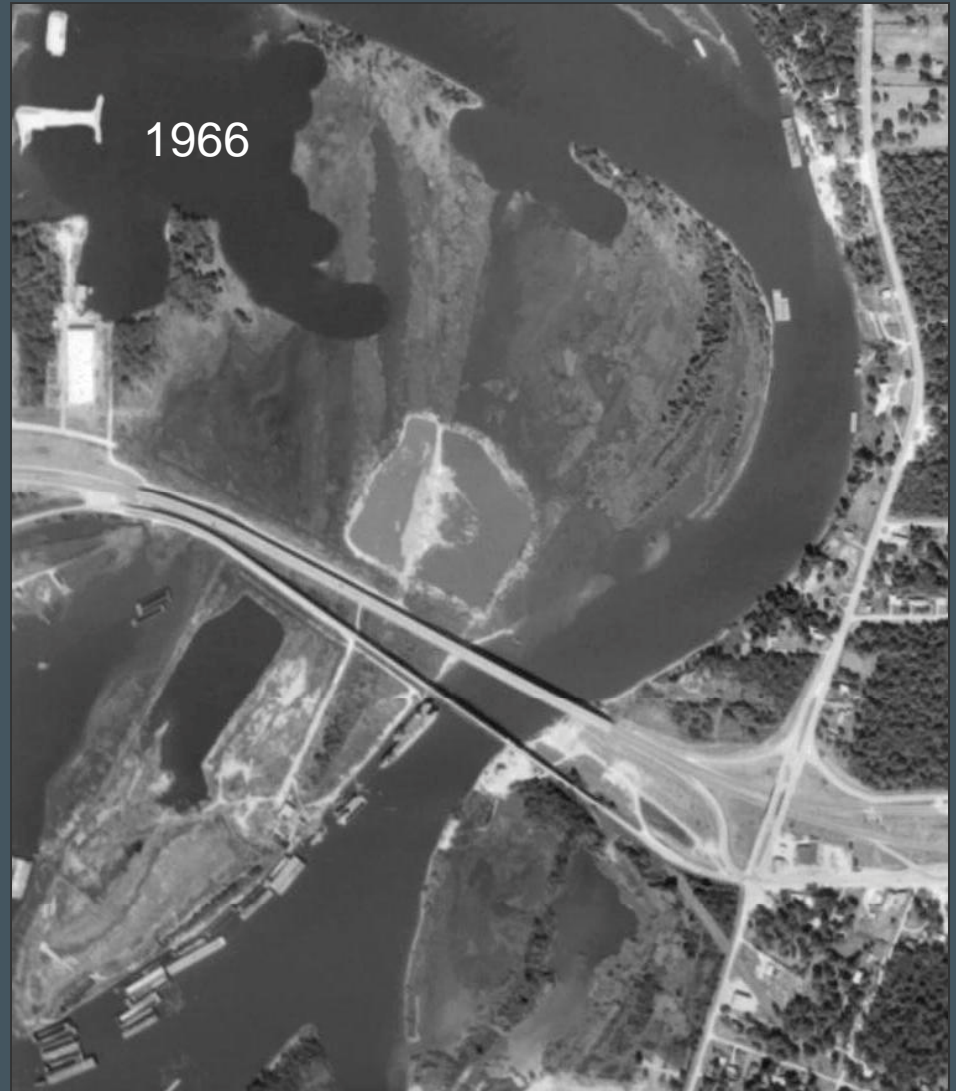
Site History

- Impoundments, built in the mid-1960s for disposal of paper mill wastes
- Total area within berms is approximately 15.7 acres

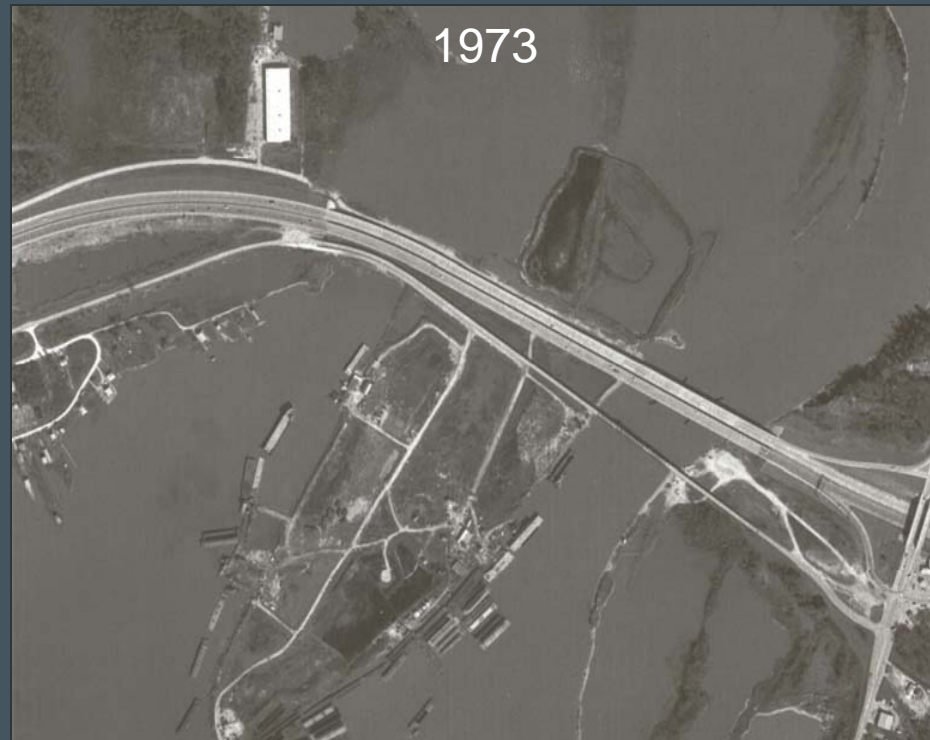
Site History (continued)

- After construction, impoundments to the were affected by subsidence and dredging activities

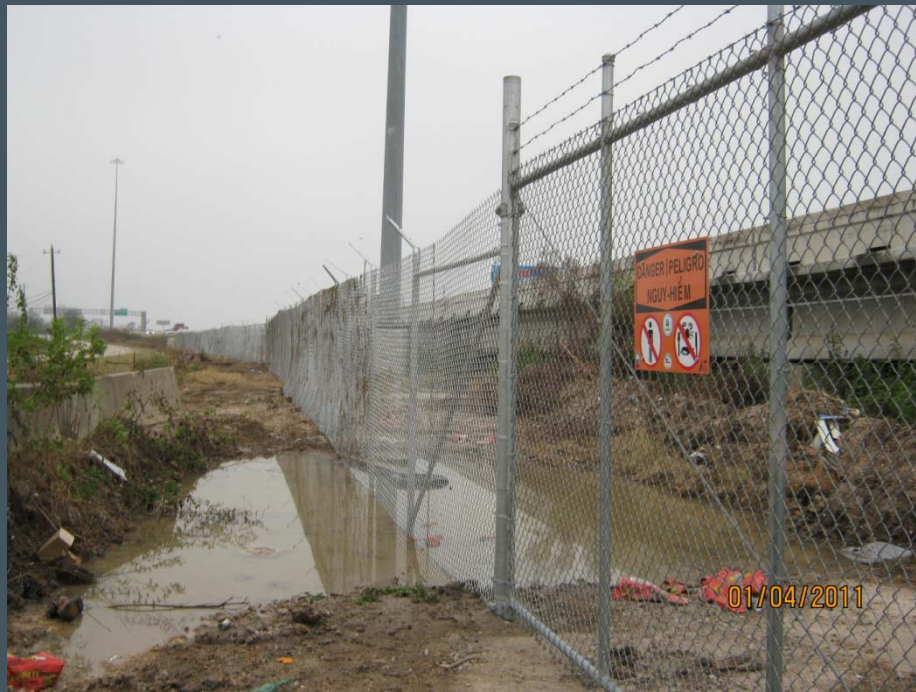
Completed Fence
Installation South of I-10

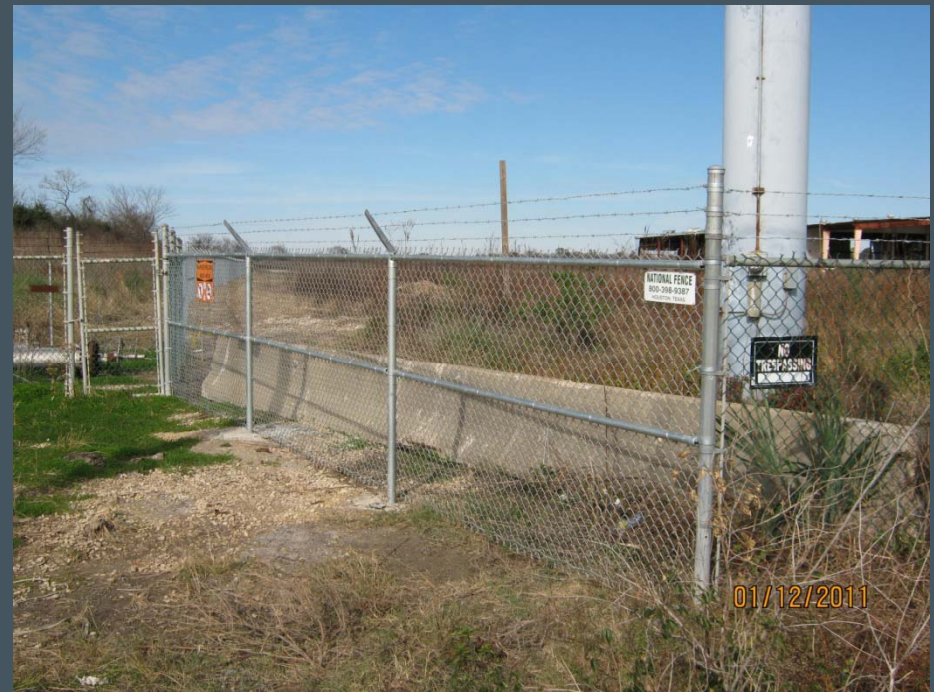
Southwest Corner of Big Star
Property Fence Installation

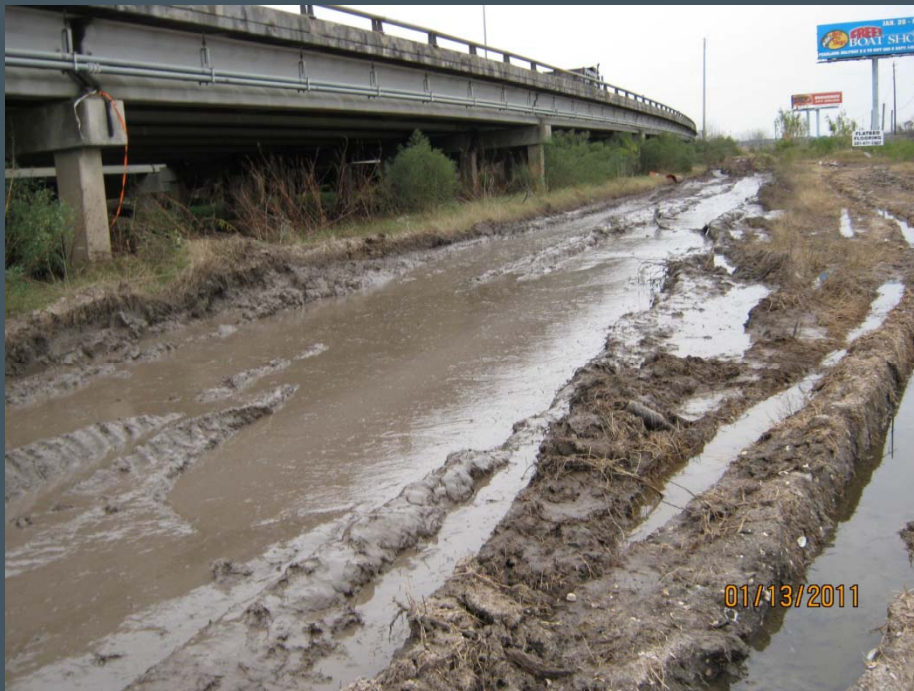
Before

Access Road

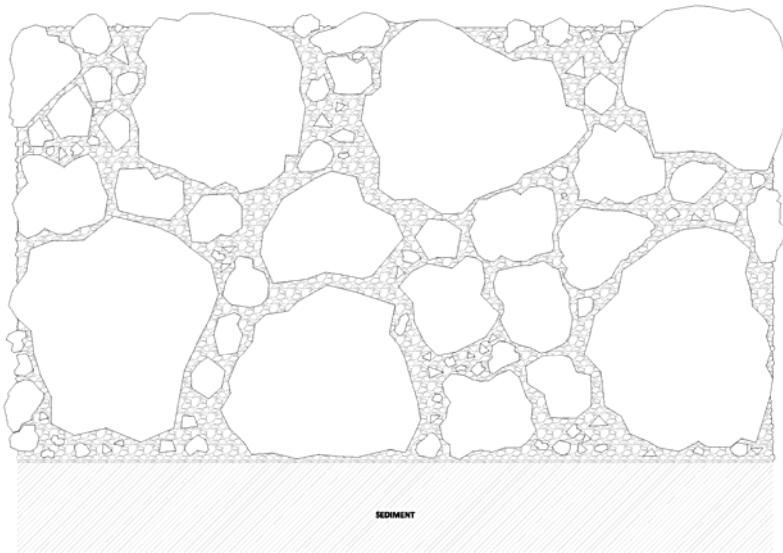
Armored Cap A

SEDIMENT

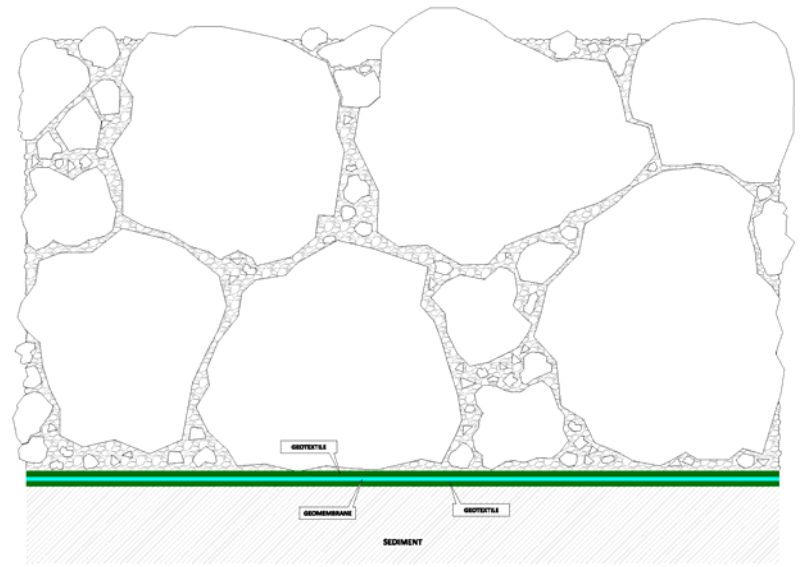
Armored Cap B/C

GEOTEXTILE

SEDIMENT

12 inch
min.

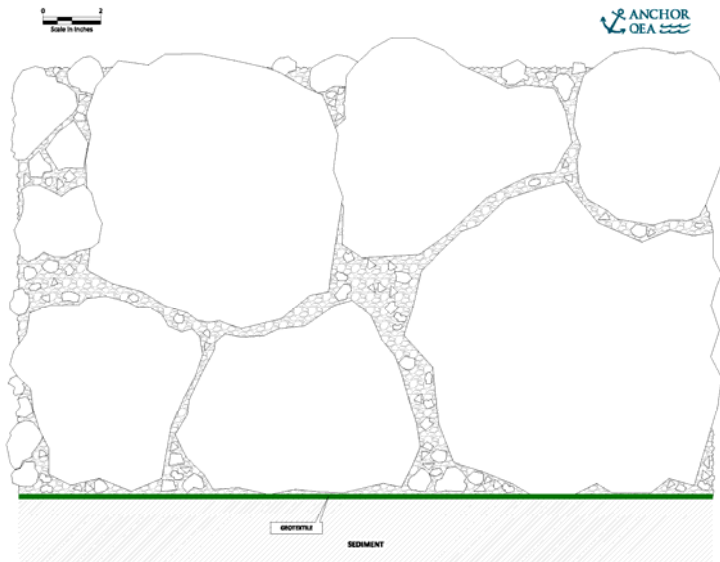
Armored Cap C

12 inch
min.

18 inch
min.

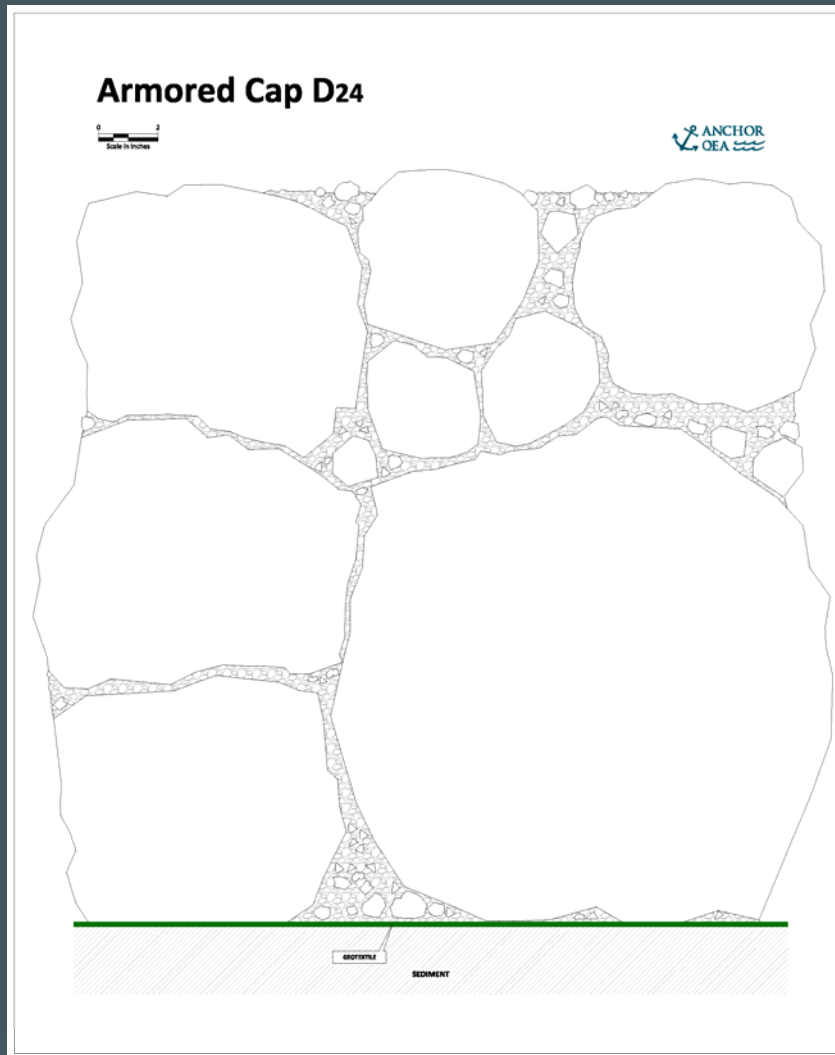
Armor Cap Type D-24

24 inch min.

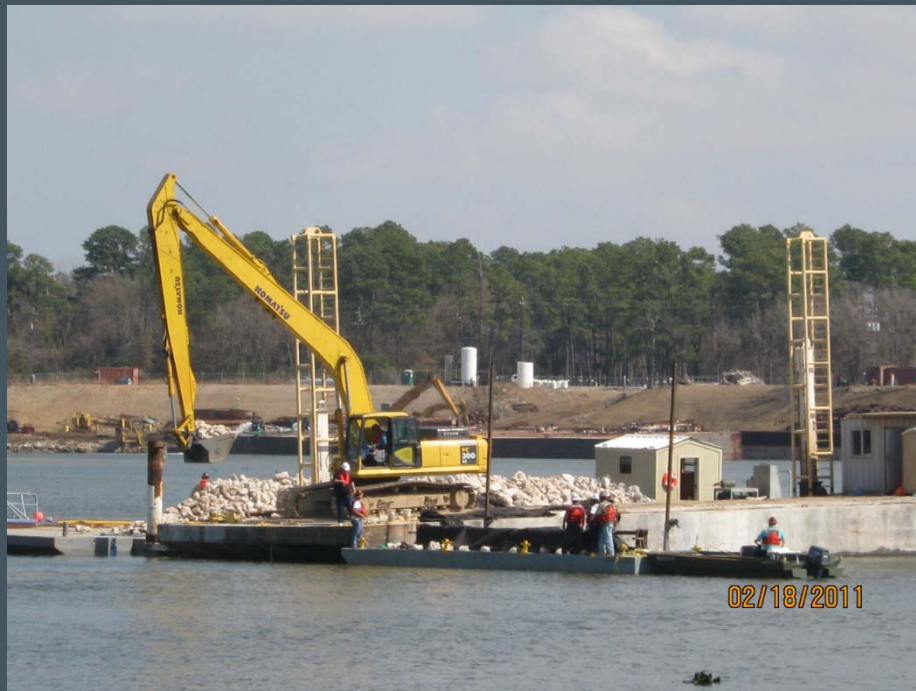
Placement of Armor Cap D
Material on Eastern Cell

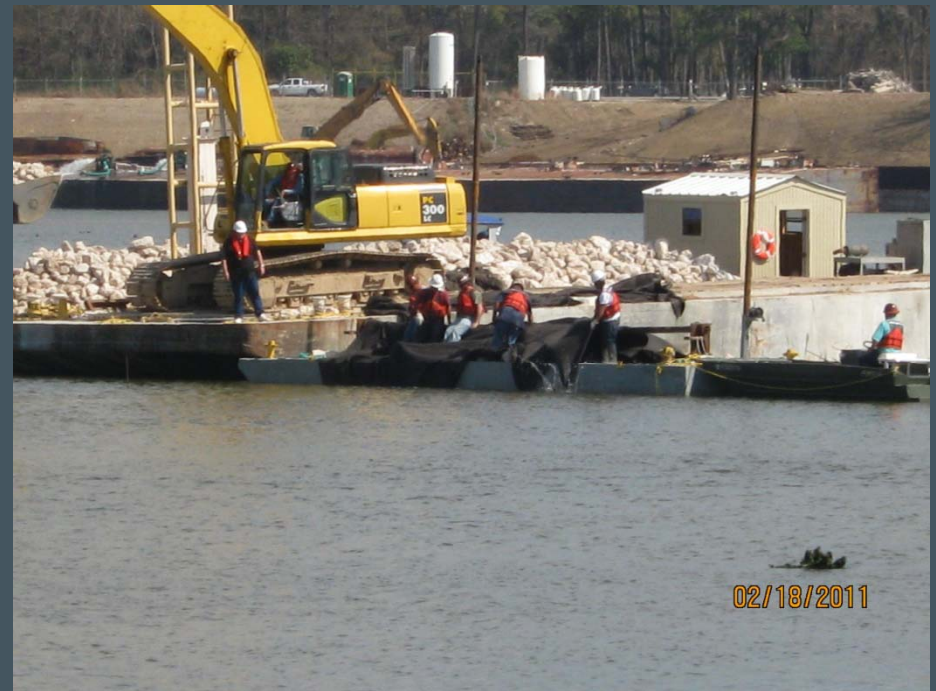
Placement of Armor Cap D and
Geotextile Material on Eastern Cell

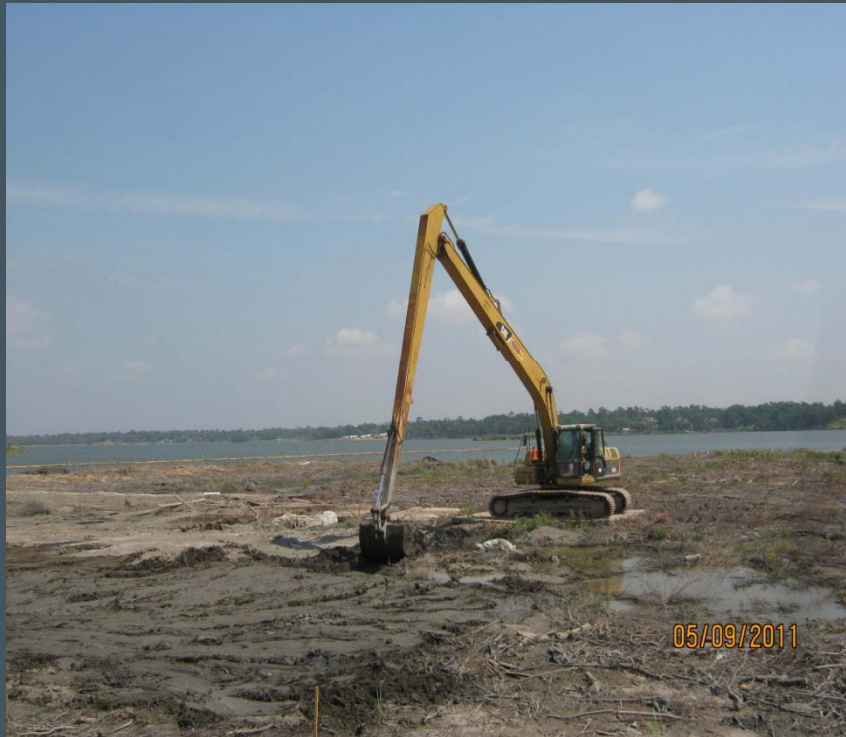
Waste Solidification

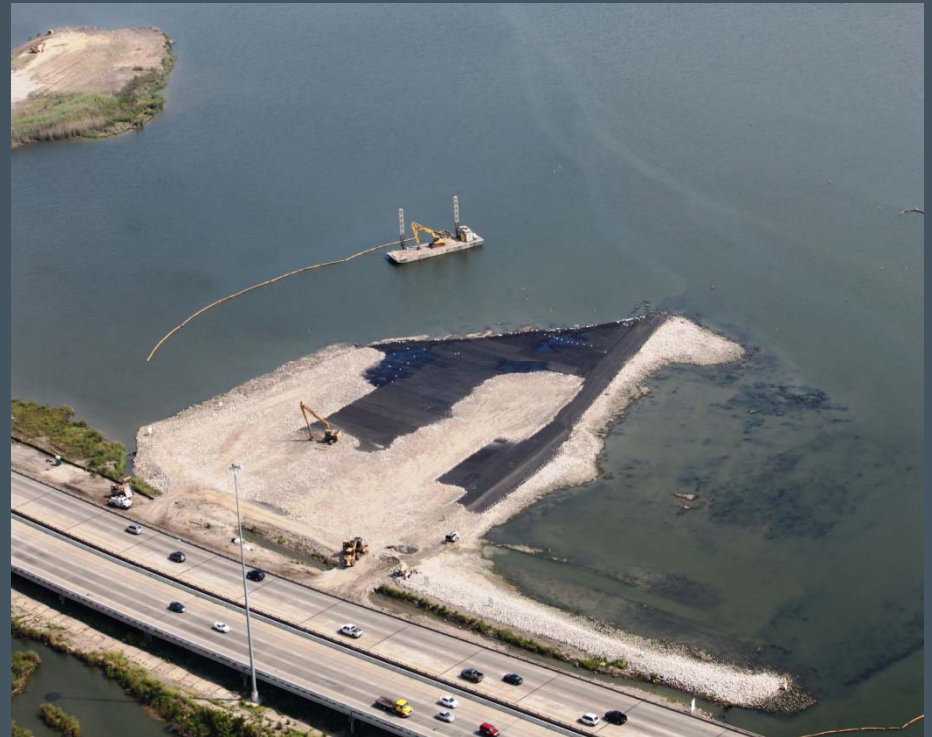
Geotextile, Geomembrane
and Rock Placement

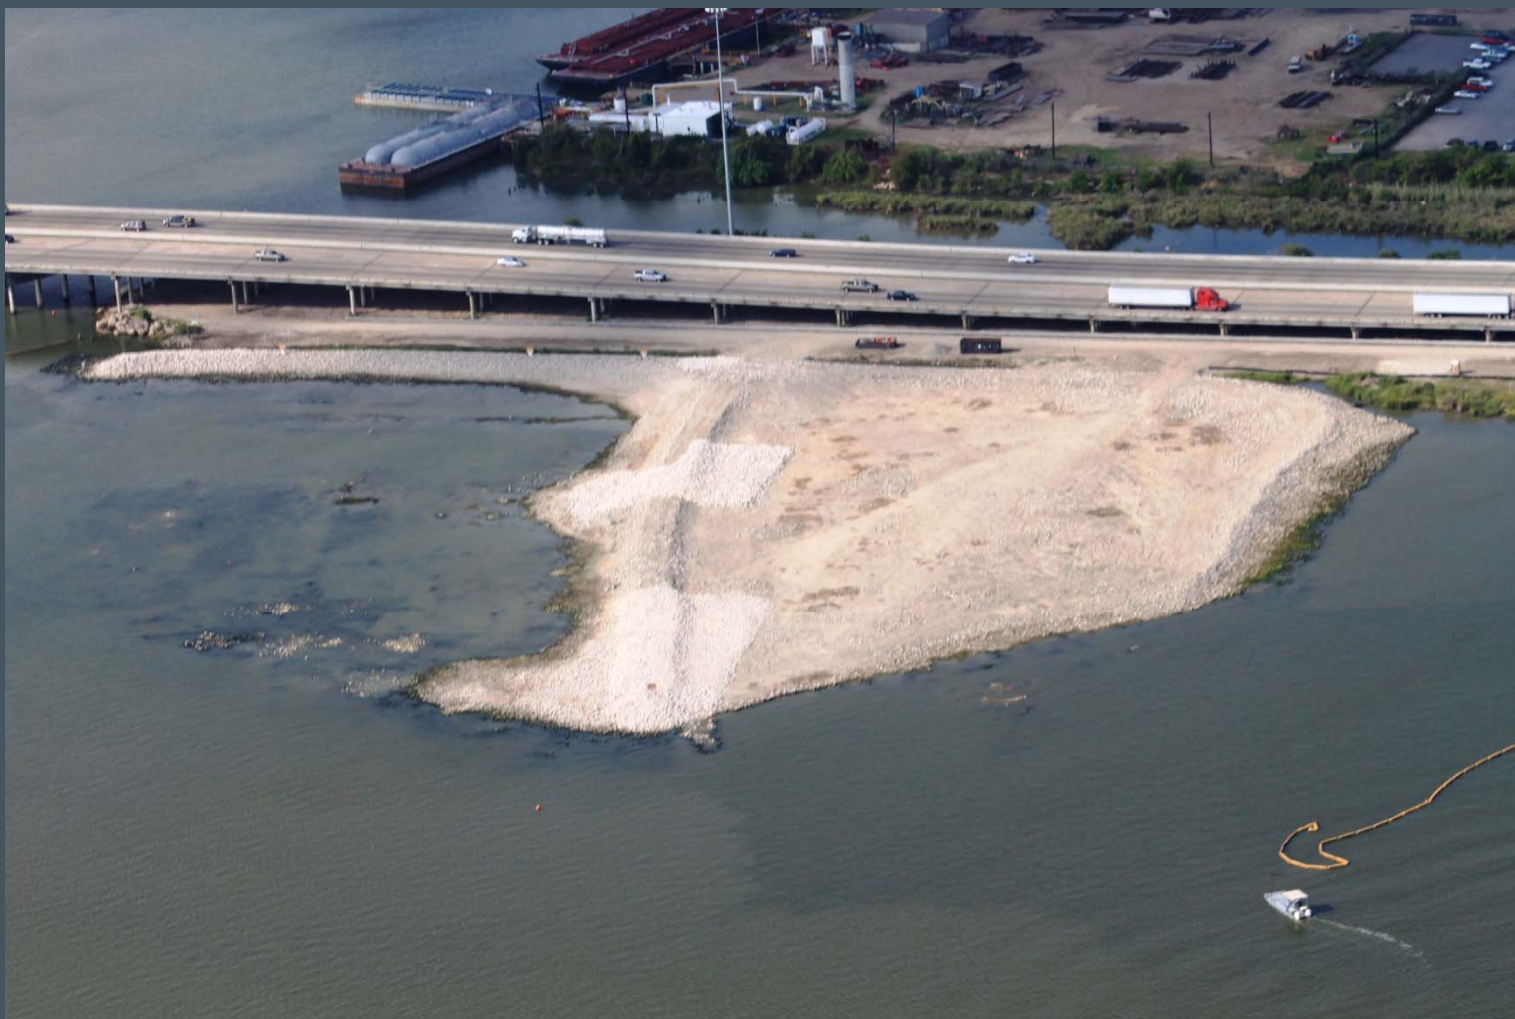
Completed Cap (July 14, 2011)
